A Case Study of the Krishna Bhir Slope Failure Disaster: Past and Present Scenario at a Glance

Sumit Maskey

Department of Earthquake Engineering Research and Training, National Society of Earthquake Technology – Nepal (NSET), Kathmandu, Nepal

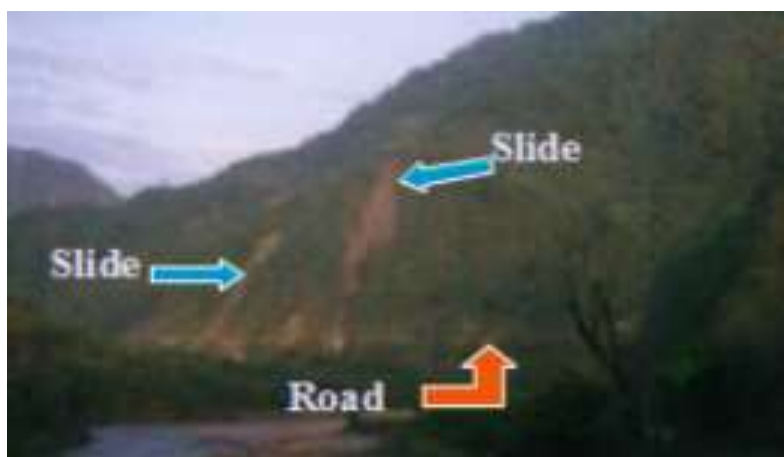
Fig. 1. Landslide of 1999 AD. Image Courtesy: S. Dwidivi (DWIDP).

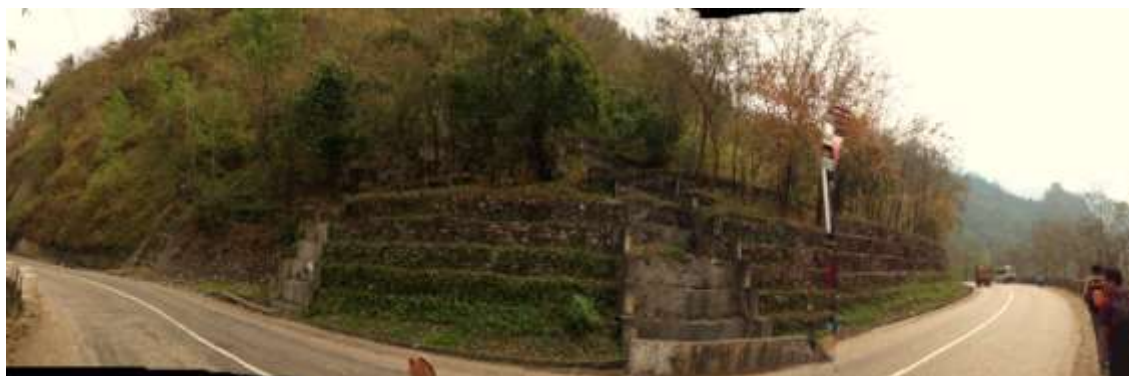
The novel concept of bio-engineering and tradition civil engineering methods were implemented by the Department of Road – Nepal aiming to strengthen the slope and manage the mass movement as shown in Figure 3. This has been a very effective solution since, this approach has sustained

Fig. 3. Prithivi Highway and Krishna Bhir at Present (View From the Highway).

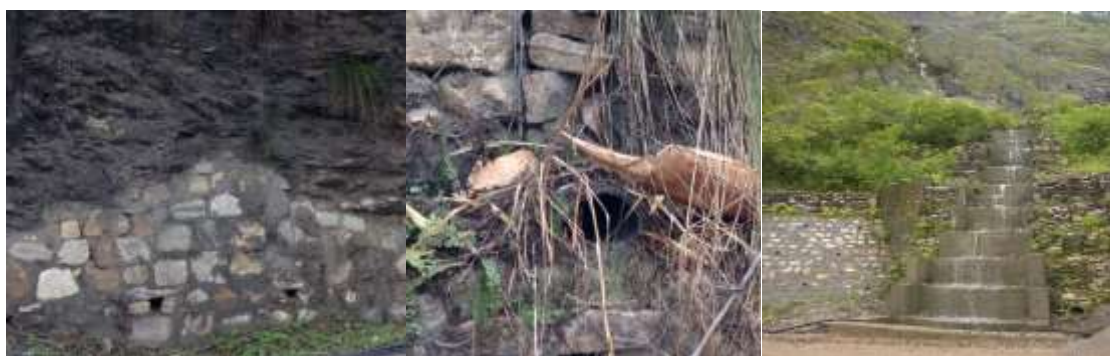
(a) Stone Masonry Wall with Weep Holes for Drainage

(b) Artificial Drain Pipes in the Gabion Walls

(c) Cascade Structure

Fig. 4. Civil Engineering Structures Built to Manage the Landslide.

Krishna bhir landslide was becoming a major mayhem for the transportation system of the nation. In 2004, Department of Road – Nepal (DOR) under to expert supervision of Er. N. M. Shakya carried out their wise management measure to minimize the perpetual slope failure disaster. DOR purposed a method that combined civil engineering technique and bio engineering technique. In depth procedures and methodology of the work initiated are beyond the scope of this research. Due to a very huge area of the slope, the movement of the mass (soil and rock) was controlled by civil engineering structure and slope protection was carried out by the bio-engineering technique. The debris flow at the midst and lower portions of the slope were managed by civil engineering approach and the lower parts were strengthen by bio-engineering technique. Figures 4 and 5 show the civil engineering structures constructed and bio-engineering vegetation planted to stabilize the slope. It could have been highly uneconomical and daunting effort to construct the civil engineering structures in the uphill zone. Hence, at toe portion of the hill, structures like the gabion wall and stone masonry wall are built. The steel reinforced gabion walls provided sufficient ductility for the active soil pressure. Simultaneously, the areas with very steep slopes were armoured with vegetation. The reinforced concrete cascades are also provided to change the direction of mass flow away from the road below. This structure also aid in collection of wasted rock and soil mass thus, dissipating the energy and velocity of the landslide. Furthermore, it also acts as a natural or artificial drain (provided with pipes) for water flow. The artificial drains are also installed at some parts in the slope by using perforated plastic pipes.

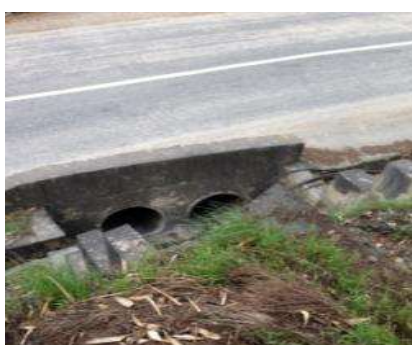
(d) Culvert

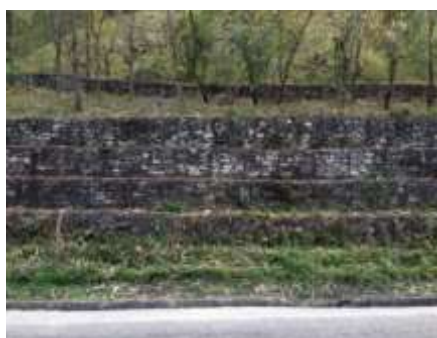
(e) Gabion Wall

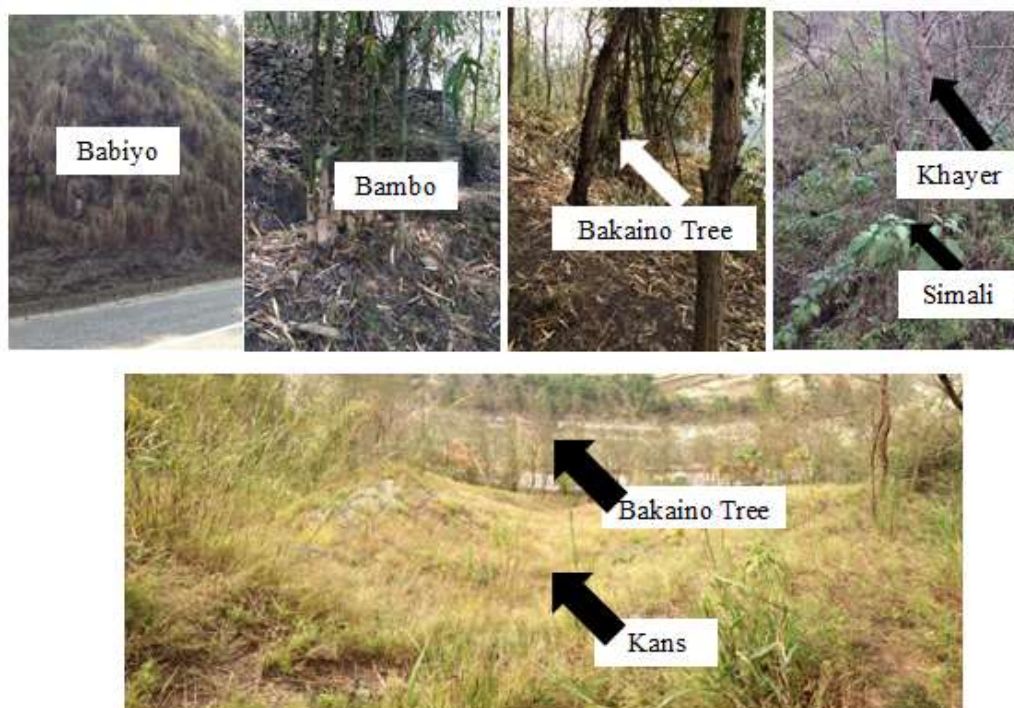
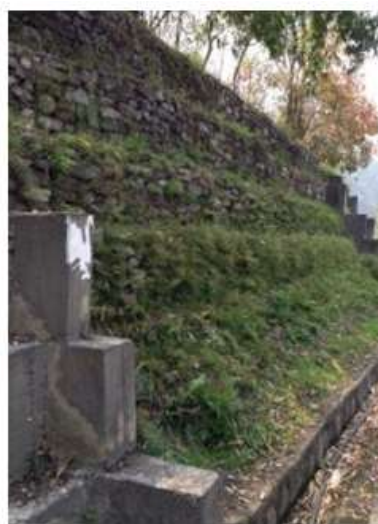
Fig. 5. Bio-engineering (Vegetation Plantation) in Krishna Bhir Slope.

The top areas of the slope is strengthened by the bio-engineering technique. The species used with their applied functions are clearly illustrated in Table 1. Once the vegetative structures have been established, it is expected to take over the entire support function, since, with time, relative strength of civil engineering structures decreased whereas, that of vegetative structures increases.^[3] Random grass and Bhujetro were planted in the area

of weathered rock mass having a severe problem of erosion. They help in armoring and binding the loose soil material and also allowed to flow the water from their surface. Bamboos also absorbed significant volume of water which helped to make the surface and subsurface flow inactive in the slope. These were some of the techniques how the slopes were given an artificial shear strength through root of plants and draining the slope surface.

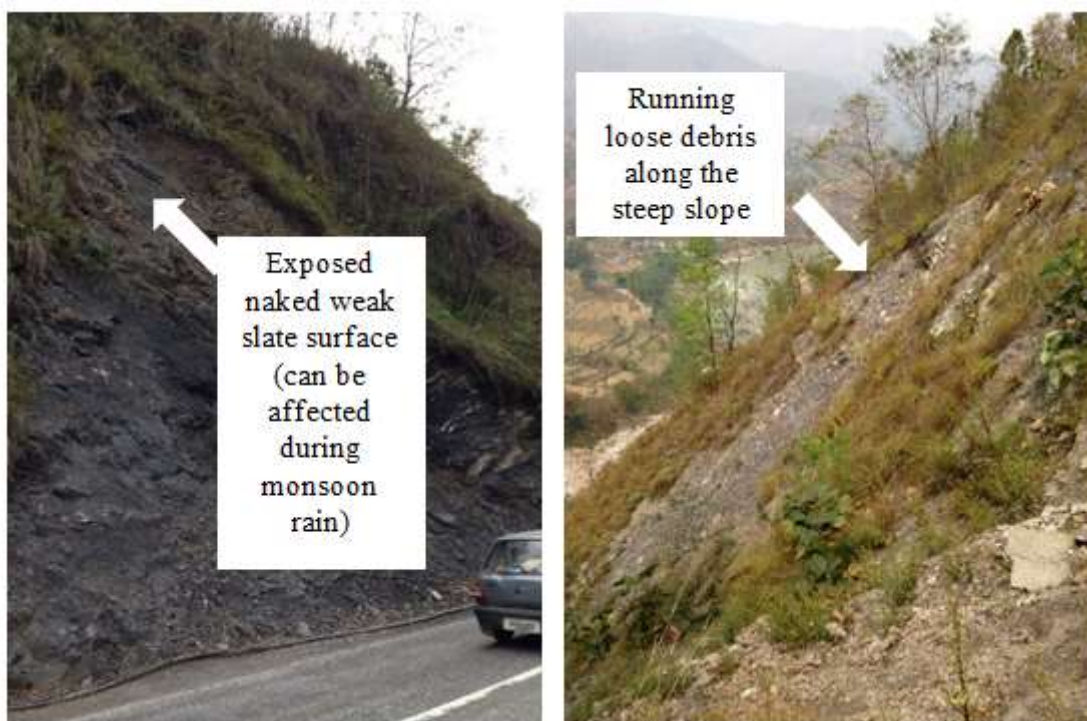
After the thorough investigation by the author in the year 2014, Krishna bhir was found to be triggering once again. As seen in Figure 6(a), the slope is weathered and exposed of Slate in the lower part which makes it highly vulnerable to erosion during the rainy season. The slopes in the upper region are still active indicated by running of loose debris along the steep slope. The symptoms of active mass movement at the midst of the slope can also be viewed from the inclined trees and highly yielded gabion walls in Figure 6(b).

(a) Exposed Krishna Bhir at Present

In order to stop the present triggering slope failure monitoring and corrective maintenance are the first steps to be initiated. In the active and exposed areas, more plantation of Babiyo should be done

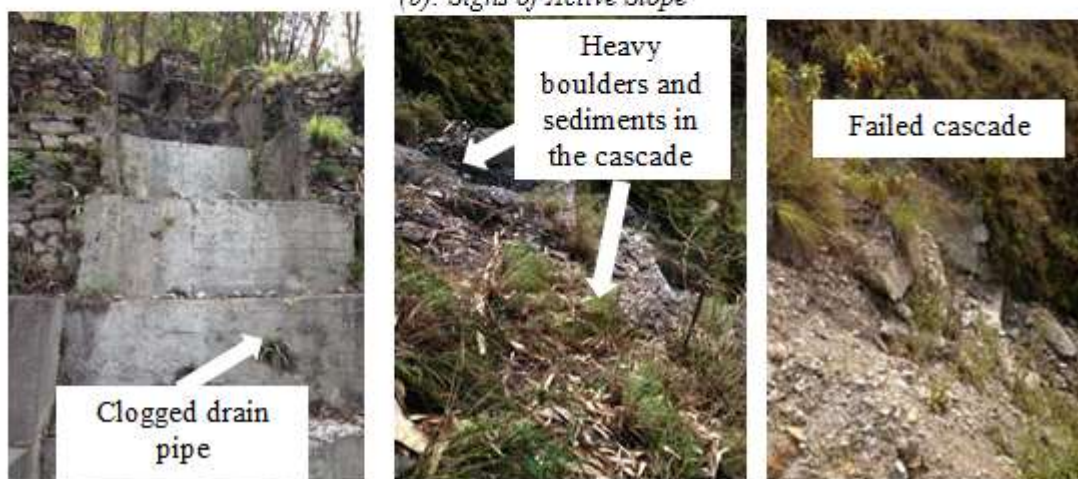
monitoring was lacking to a great extent. The existing condition of the structures has been illustrated by Figures 6(b) and (c). The artificial drains in the cascade are clogged by vegetation and debris. The path of the cascades is blocked by heavy boulders and high amount of sediments due to rock fall and landslides in the upper region. One of the cascades is damaged and failed seriously by impact of heavy rock fall and debris flow. The levity in maintenance can be visualized with failed cascades, clogged drain pipes in masonry walls and flushed artificial drains pipes along the slopes. The slopes around the vicinity of Krishna bhir were quite stable which might be due to the difference in constituent of the material in other part of the slope. These symptoms clearly show liveliness of slope with time.

(c). Present Condition of Cascades

Cleaning the clogged drain pipes, removal of debris and boulders in cascade, repair of impaired structures and more plantation of vegetation in the naked areas should be the first step to be initiated. As done in Niigata prefecture of Japan, number of survey stations should be established for accurate determination of ground surface.

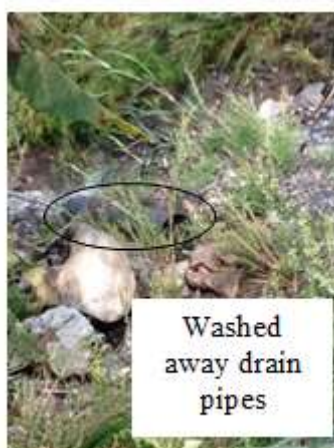
(d) Washed Away Drain Pipe

Fig. 6. The Present Condition Krishna Bhir and Stabilizing Structures.
